CANISTEAR RESERVOIR DAM

NO 1

NJ 00485

**PHASE 1 INSPECTION REPORT
NATIONAL DAM SAFETY PROGRAM**

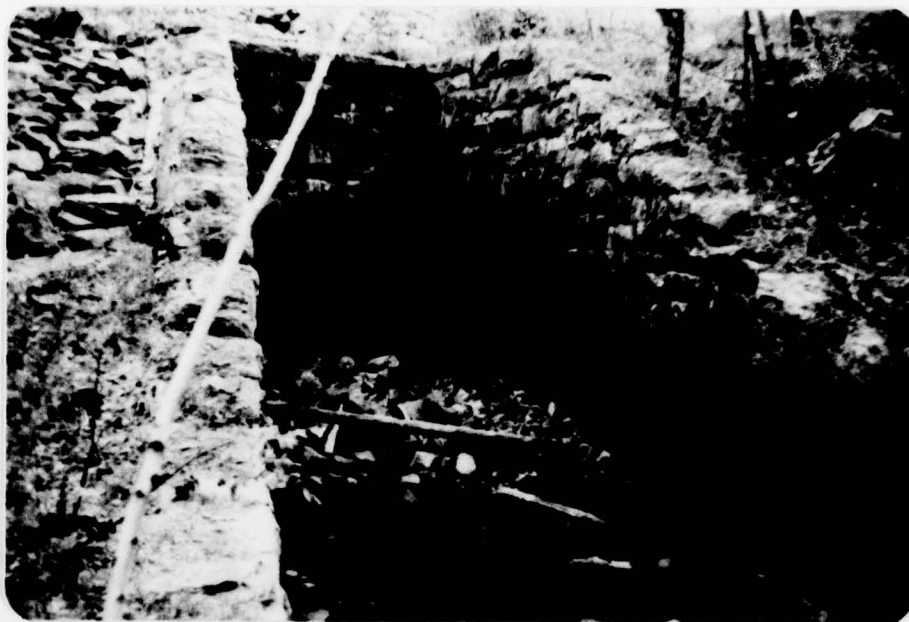
View of Outlet Structure

The design plans indicate that the 9' x 11' inlet and outlet aqueducts are identical in design with the exception of a trash gate positioned on the intake entrance. While the intake could not be seen, the outlet structure exhibits signs of its advanced age. Mortar between the dimension masonry of the wingwalls is crumbling and several blocks on the head walls are loose. Efflorescence was noted over the entire face of the structure and, within the culvert, heavy carbonate precipitation has formed miniature stalactites on the ceiling arch. Heavy seepage was noted dripping from the ceiling and sides of the tunnels and the left wingwall was wet to within five feet of its top near the headwall. Dampness on the left wingwall was limited to the bottom 3 feet near the headwall. The combination concrete, stop-log bracket and sill located near the end of the wingwalls has badly deteriorated. The outlet channel is filled with debris which consists primarily of displaced riprap and small stone although some bank erosion products are deposited at the mouth of the outlet. The gate house structure appears in satisfactory condition and new doors and landings have been installed recently. One of the four gate valves is inoperative due to a missing stem and wheel. While the three remaining valves can be operated, their adjustment has become so stiff, it requires several men to operate each wheel, according to City Engineers.

VISUAL EXAMINATION OF	OBSERVATIONS	REMARKS OR RECOMMENDATIONS
CRACKING AND SPALLING OF CONCRETE SURFACES IN OUTLET CONDUIT	Spalling - cracking of joints, efflorescence heavy inside conduit. Blocks working loose at base of both wingwalls and piers.	Heavy seepage from ceiling, left wing wall starting 5.5' from top. Light seepage at base of right wingwall.
INTAKE STRUCTURE	Not visible	
OUTLET STRUCTURE	Heavy efflorescence - Loaded with riprap from above open cracks between masonry spalling behind.	Stilling structure deteriorated badly - step or log missing. Constricting concrete bracket and foot slot of "stop log" structure at end of channel completely disintegrated.
OUTLET CHANNEL	Loaded with riprap rubble from the backslope 6' high bedrock outcrop 3' wide 6' long through left wingwall.	There should be a cyclone fence around the edge of the structure to prevent accidental falls into the 18 foot deep outlet.

1. Clean the downstream outlet of displaced riprap stone and replace same above the outlet headwall.
2. Repoint and reset all exposed stone masonry in the outlet walls.
3. Replace the antiquated valves in the gate chamber.
4. Continue to monitor and record seepage and groundwater characteristics in the vicinity of the abutment backslopes and the outlet retaining walls.
